Stabilizing the Landslide on Road E87 Burgas – Malko Tarnovo, Bulgaria

Abstract

Bulgaria is a country with a relief of various elevations. This is a precondition for appearance of landslides of different types. The present study deals with stabilizing approaches for a landslide on the road between two towns in Bulgaria.

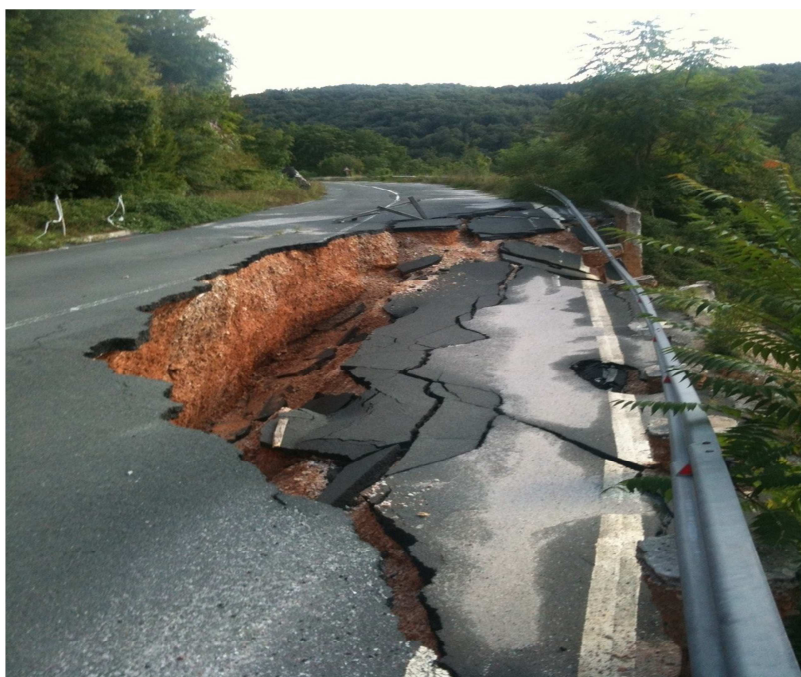
A landslide was triggered again after the 2010 spring snow melt causing a total vertical collapse of the right lane to approx. 2,50 m and horizontal displacement of part of the central lamellas of the retaining wall with amplitude of 10,00-20,00cm. Some lamellas, together with the piles underneath, were completely destroyed. Numerous descending springs were observed in the last one third of the landslide body and the toe was established in the floodplain of the river flowing in the slope base. The landslide has the following dimensions: landslide body area – 2210,0 m², length – 80,0 m and depth – up to 11,0 m.

Figure 1: A photo of the road section affected by the 2010 landslide in the direction of the town of Malko Tarnovo

Figure 1 and Figure 2 show the road pavement failures due to the 2010 landslide.

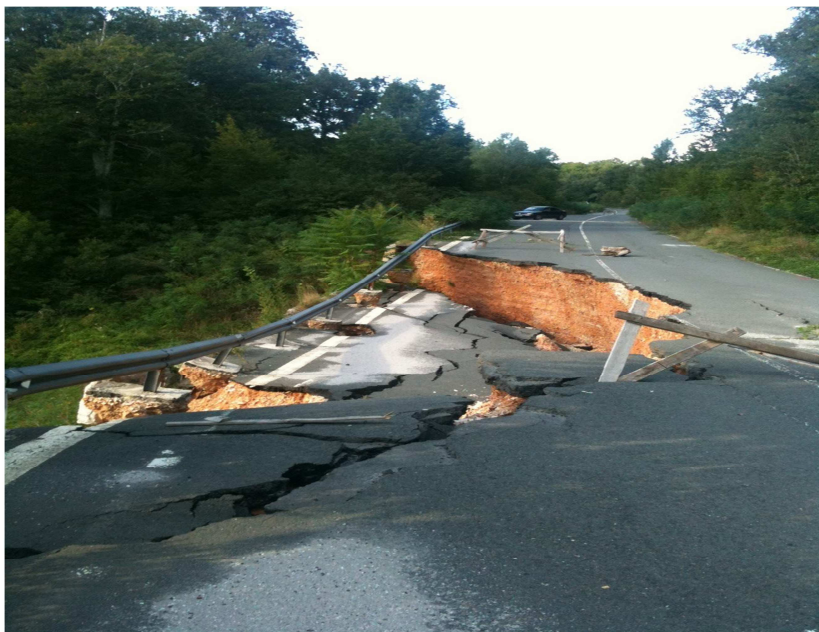
Figure 2: A photo of the road section affected by the 2010 landslide in the direction of the city of Burgas
